**Flood Control Project Maintenance**  
**Levee Inspections**

**Fall 2012 Levee Maintenance Deficiency Summary Report**

**Reclamation District No. 1001 Nicolaus**

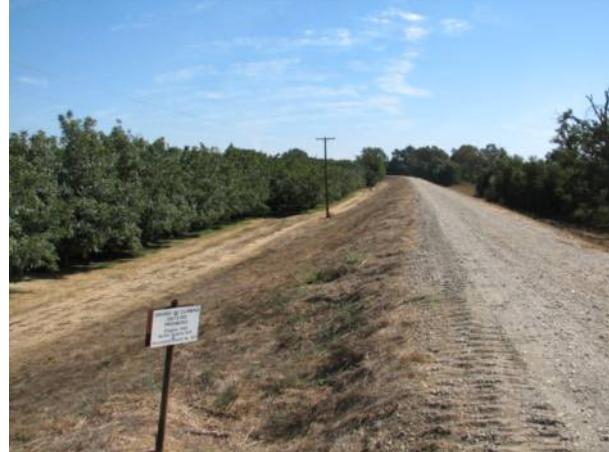
cathom\_f\_20121106\_234.JPG

This photo is the landside slope at levee mile 3.78.

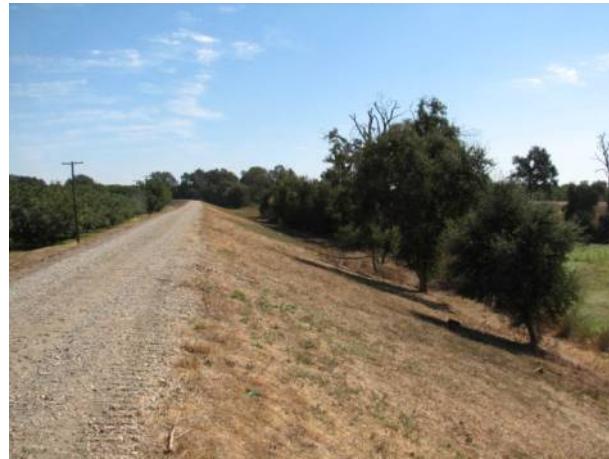
cathom\_f\_20121106\_233.JPG

Levee Mile Report Line	5
Start Levee Mile	0.48
End Levee Mile	3.78
Location	Water Side
Category	Earthen Levee
Item	Vegetation

This photo is the waterside slope at levee mile 3.78.

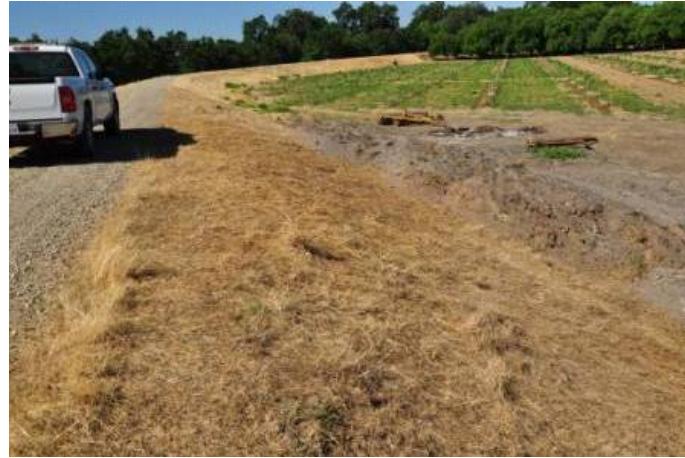
cathom\_f\_20120912\_098.JPG

Levee Mile Report Line	7
Start Levee Mile	2.99
End Levee Mile	2.99
Location	Land Side
Category	Earthen Levee
Item	Encroachments

RD 1001 Unit 1 -L/S - Debris

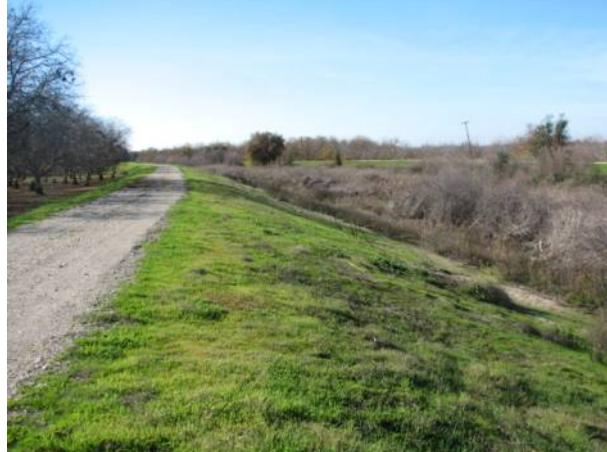
Levee Mile Report Line	1
Start Levee Mile	0.04
End Levee Mile	3.65
Location	Water Side
Category	Earthen Levee
Item	Vegetation
This photo is of the waterside slope at levee mile 0.92.	
cathom_f_20121128_238.JPG

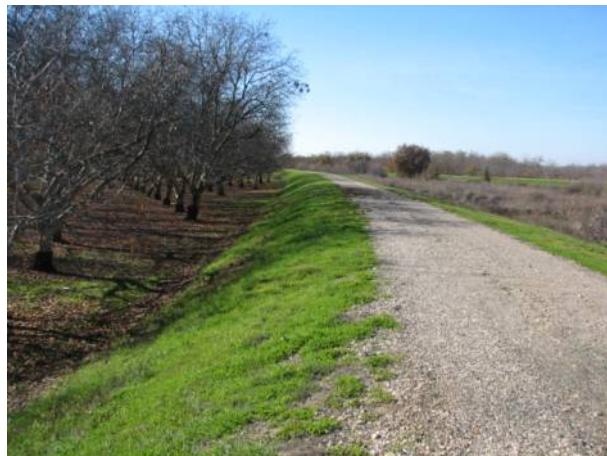
Levee Mile Report Line	2
Start Levee Mile	0.04
End Levee Mile	3.65
Location	Land Side
Category	Earthen Levee
Item	Vegetation
This photo shows the landside slope at levee mile 0.92.	
cathom_f_20121128_239.JPG

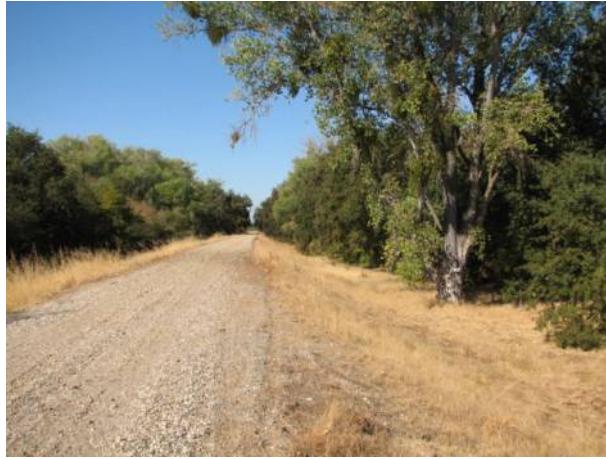
Levee Mile Report Line	3
Start Levee Mile	0.14
End Levee Mile	6.66
Location	Water Side
Category	Earthen Levee
Item	Vegetation
This photo shows the waterside slope at levee mile 0.00.	
cathom_f_20121106_230.JPG

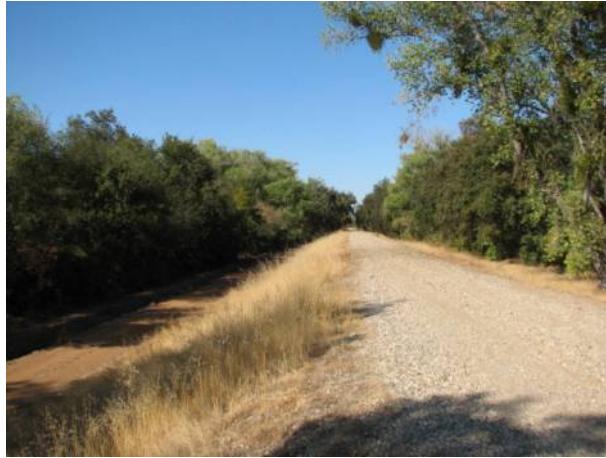
Levee Mile Report Line	4
Start Levee Mile	0.14
End Levee Mile	7.30
Location	Land Side
Category	Earthen Levee
Item	Vegetation
This photo shows the landside slope at levee mile 0.00.	
cathom_f_20121106_231.JPG

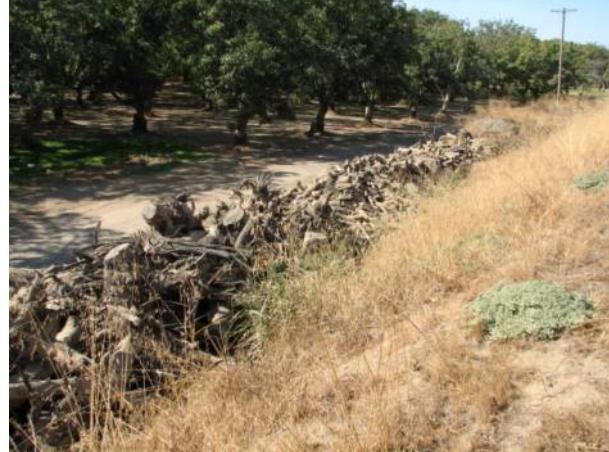
Levee Mile Report Line	12
Start Levee Mile	3.85
End Levee Mile	3.85
Location	Land Side
Category	Earthen Levee
Item	Encroachments
Levee mile 3.85, debris on the levee toe and slope.	
cathom_f_20121106_232.JPG

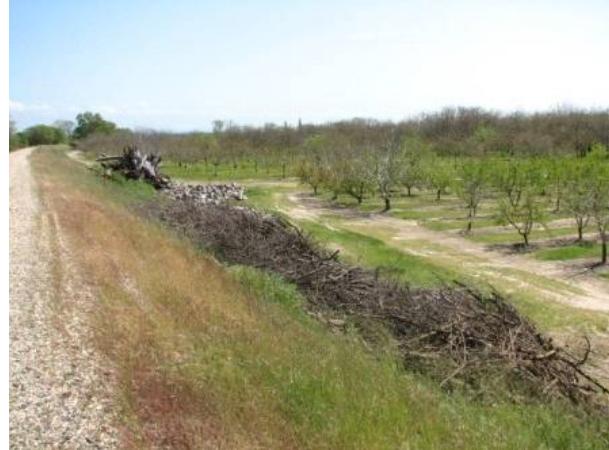
Levee Mile Report Line	17
Start Levee Mile	4.50
End Levee Mile	4.59
Location	Land Side
Category	Earthen Levee
Item	Encroachments
Levee mile 4.54, this photo is looking at the prunings on the landside slope and toe.	
cathom_f_20120912_117.jpg

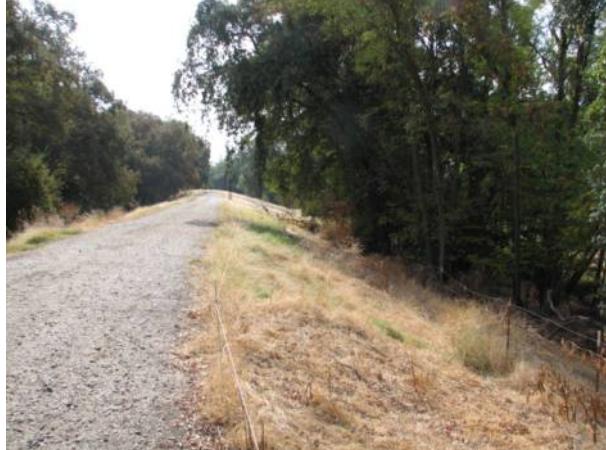
cathom\_f\_20121106\_237.JPG

This photo shows the waterside vegetation at levee mile 0.00.

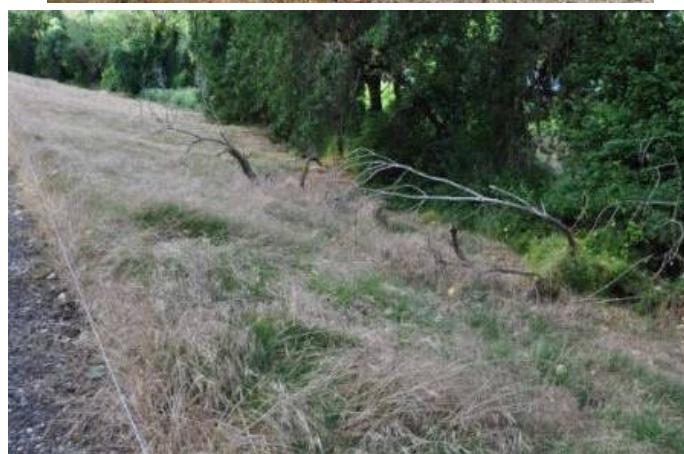
cathom\_f\_20120912\_173.JPG

Levee Mile Report Line	3
Start Levee Mile	0.25
End Levee Mile	0.25
Location	Water Side
Category	Earthen Levee
Item	Encroachments

RD 1001 Unit 4 - W/S slope - Limb

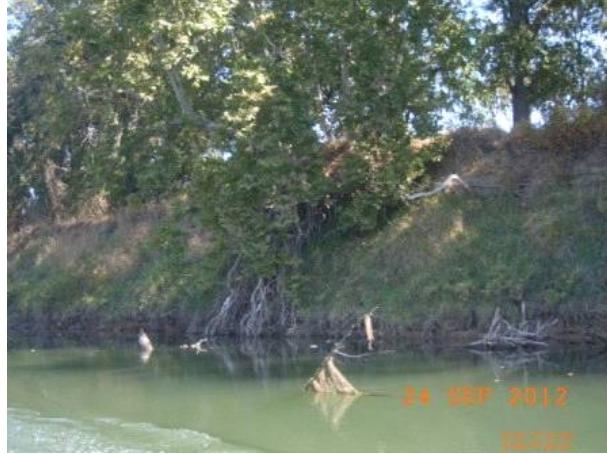
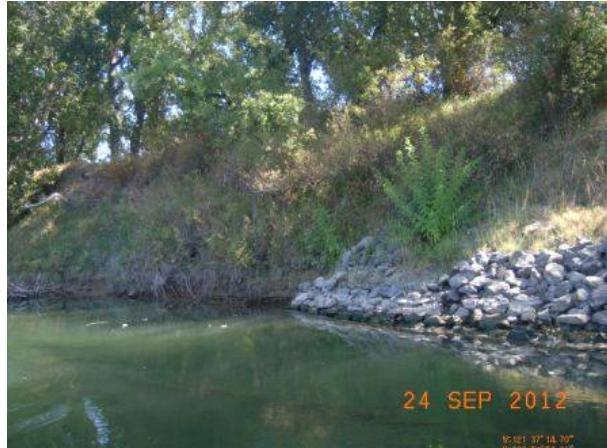
10	6.47	6.57	Supplemental USACE Erosion Survey	USACE Erosion	WS Ma	M	Inspector Comments: 2011 - Tall slumping sections. Scour around trees has exposed most of the roots. 2012: No observed change. [2012 Site ID: FHR_6-0_L]	38.865875 ° -121.619983 °	38.864706 ° -121.620813 °	2 Y	DWR ID:
11	6.48	6.48	Earthen Levee	Vegetation	LS En	M	V6 : Landscaping	38.865653 ° -121.619742 °	38.865653 ° -121.619742 °	17 Y	DWR ID: DWR_RD1001_04_s_2012_17
12	6.63	6.88	Supplemental USACE Erosion Survey	USACE Erosion	WS Ma	M	Inspector Comments: 2011 - Large slumped sections on the lower bank. 2012: No observed change. [2012 Site ID: FHR_5-8_L]	38.863946 ° -121.621388 °	38.861558 ° -121.623316 °	4 Y	DWR ID:
13	6.64	6.64	Earthen Levee	Vegetation	LS Ma	M	V4 : Elderberries are blocking visibility and flood fight capability.	38.863700 ° -121.621198 °	38.863700 ° -121.621198 °	18 Y	DWR ID: DWR_RD1001_04_s_2012_18
14	6.73	6.73	Earthen Levee	Animal Control	LS Ma	C	A3 : No rodents visible, but rodent burrows visible; need to backfill and compact or grout burrows.	38.862607 ° -121.621891 °	38.862607 ° -121.621891 °	10 Y	DWR ID: DWR_RD1001_04_s_2012_10

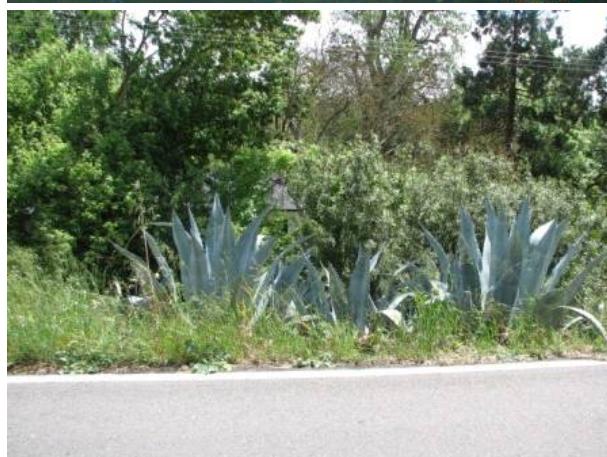
cathom\_f\_20120912\_153.jpg

Landscaping on the landside shoulder and slope levee mile 6.48.

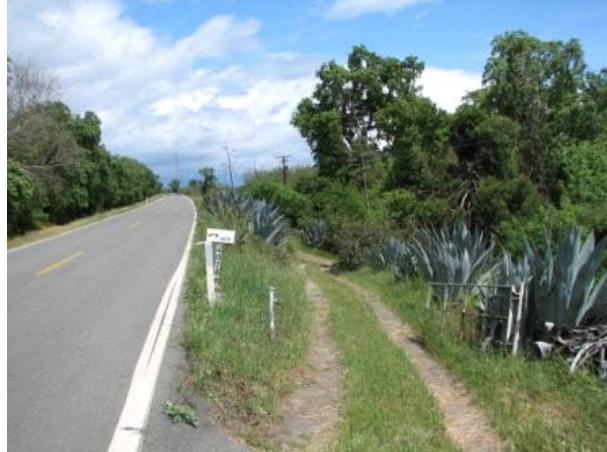
Levee Mile Report Line	11
Start Levee Mile	6.48
End Levee Mile	6.48
Location	Land Side
Category	Earthen Levee
Item	Vegetation
Landscaping levee mile 6.48.	
cathom_f_20120912_154.jpg

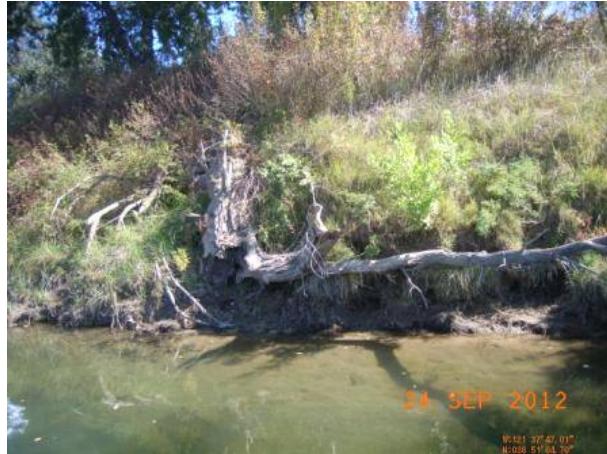
USACE 2012 Photo #2

Levee Mile Report Line	16
Start Levee Mile	7.54
End Levee Mile	7.86
Location	Water Side
Category	Supplemental
Item	USACE Erosion Survey

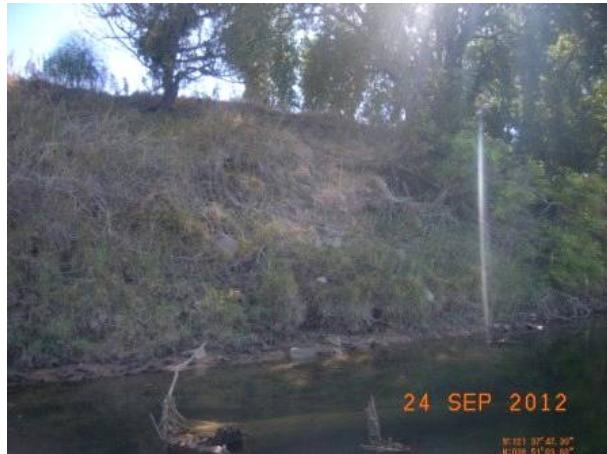
USACE 2012 Photo #3

Levee Mile Report Line	16
Start Levee Mile	7.54
End Levee Mile	7.86
Location	Water Side
Category	Supplemental
Item	USACE Erosion Survey

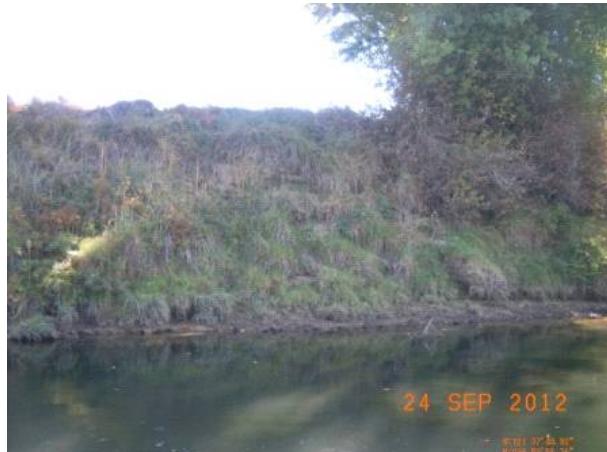
USACE 2012 Photo #5

Levee Mile Report Line	16
Start Levee Mile	7.54
End Levee Mile	7.86
Location	Water Side
Category	Supplemental
Item	USACE Erosion Survey

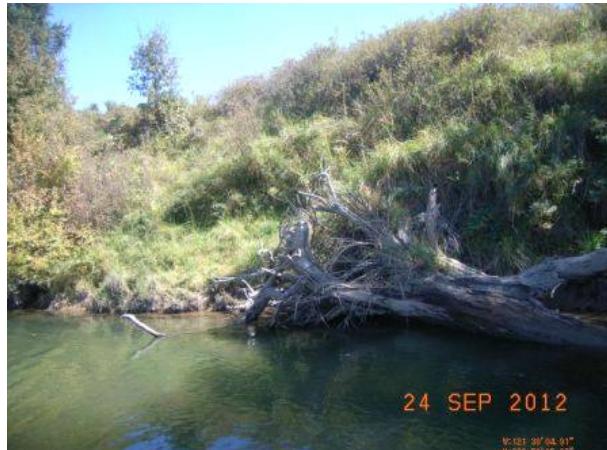
USACE 2012 Photo #3

17	8.61	9.01	Supplemental USACE Erosion Survey	Erosion	WS Ma	M	Inspector Comments: 2006 - Sandy, silty bank with intermittent pockets of erosion. Rotational failure and tree pop outs are most of the problem. Some upper slope fluvial erosion. 2010 - Site extended upstream. The lower Feather may benefit from a regional repair. 2011 - Site combined with 3.6. Minimal new erosion. 2012: No observed change. [2012 Site ID: FHR_3-8_L]	38.836966 ° -121.634128 °	38.831498 ° -121.636371 °	6 Y	DWR ID:
18	8.72	8.72	Earthen Levee	Vegetation	LS Ma	M	V4 : Elderberries are blocking visibility and flood fight capability.	38.835766 ° -121.633966 °	38.835766 ° -121.633966 °	12 Y	DWR ID: DWR_RD1001_04_s_2012_12
19	9.74	9.74	Earthen Levee	Vegetation	WS En	M	V6 : Landscaping	38.833088 ° -121.635103 °	38.833088 ° -121.635103 °	21 Y	DWR ID: DWR_RD1001_04_s_2012_21
20	10.16	10.16	Earthen Levee	Slope Stability	WS Ma	C	S3 : Repair the levee slope damaged by vehicle traffic and prevent access where possible.	38.816282 ° -121.637502 °	38.816282 ° -121.637502 °	150 Y	DWR ID: DWR_RD1001_04_s_2012_150

Levee Mile Report Line	17
Start Levee Mile	8.61
End Levee Mile	9.01
Location	Water Side
Category	Supplemental
Item	USACE Erosion Survey

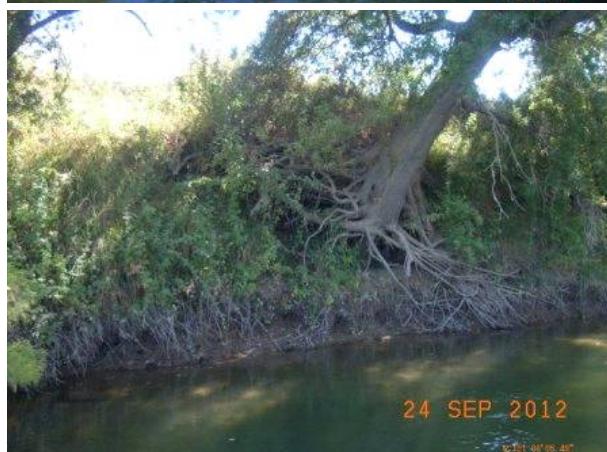
USACE 2012 Photo #4

Levee Mile Report Line	17
Start Levee Mile	8.61
End Levee Mile	9.01
Location	Water Side
Category	Supplemental
Item	USACE Erosion Survey

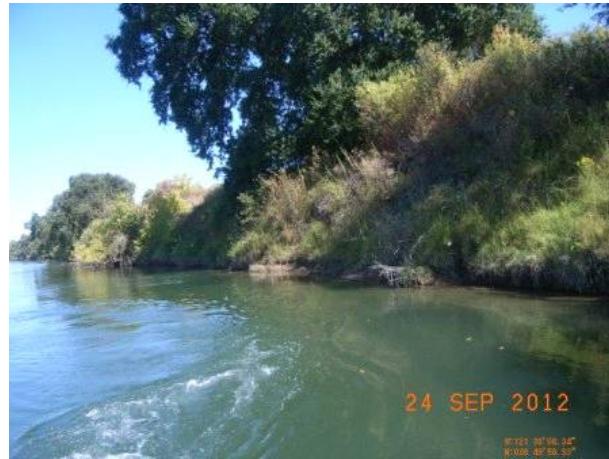
USACE 2012 Photo #6

Levee Mile Report Line	17
Start Levee Mile	8.61
End Levee Mile	9.01
Location	Water Side
Category	Supplemental
Item	USACE Erosion Survey

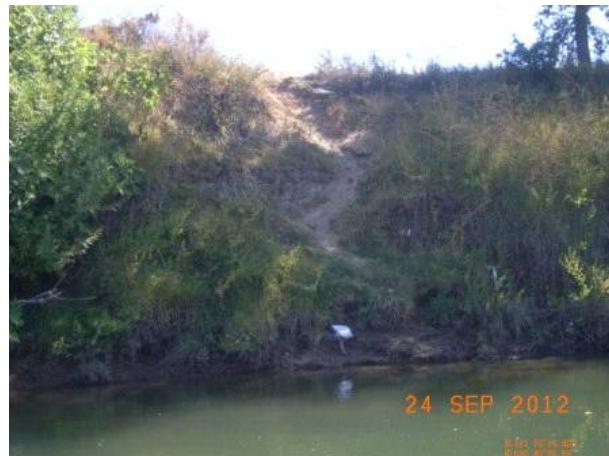
USACE 2012 Photo #7

Levee Mile Report Line	17
Start Levee Mile	8.61
End Levee Mile	9.01
Location	Water Side
Category	Supplemental
Item	USACE Erosion Survey

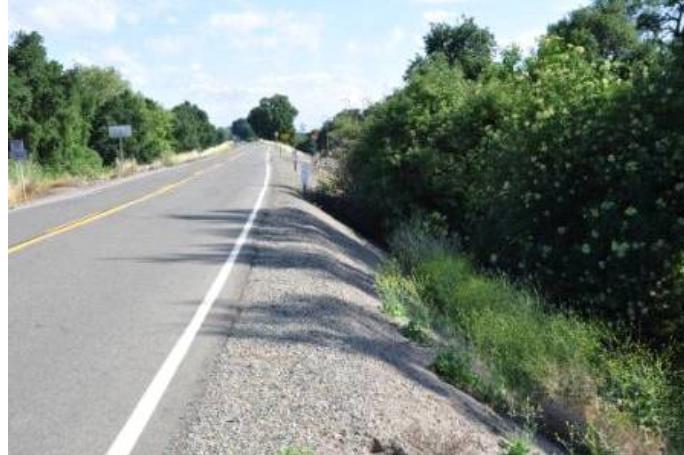
Levee Mile Report Line	18
Start Levee Mile	8.72
End Levee Mile	8.72
Location	Land Side
Category	Earthen Levee
Item	Vegetation

RD 1001 Unit 4 - W/S slope - Elderberries

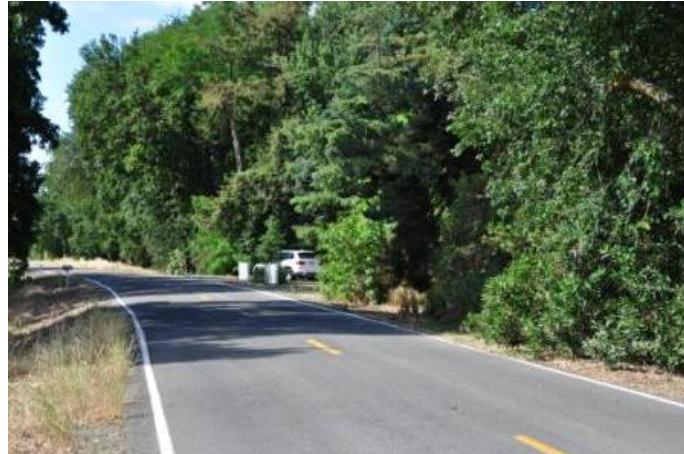
Levee Mile Report Line	19
Start Levee Mile	9.74
End Levee Mile	9.74
Location	Water Side
Category	Earthen Levee
Item	Vegetation

RD 1001 Unit 4 - W/S slope -Landscaping/Trees

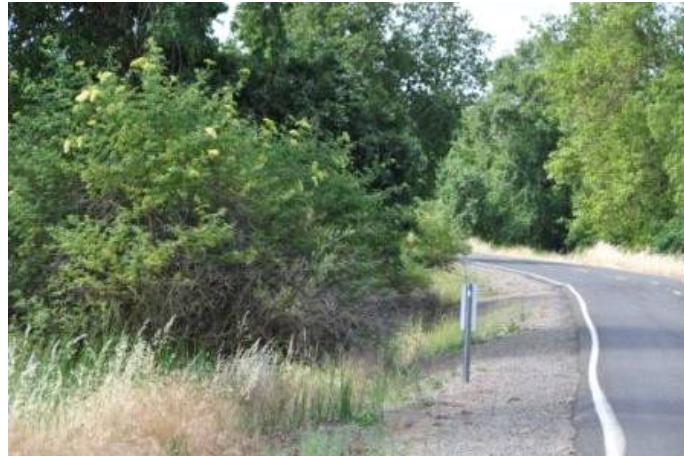
RD 1001 Unit 4 - L/S slope - Elderberries

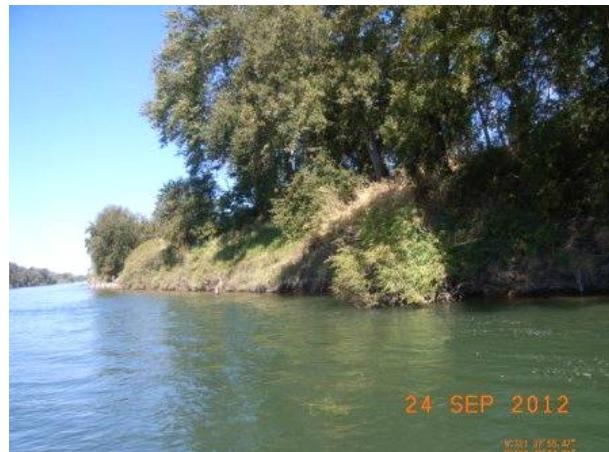
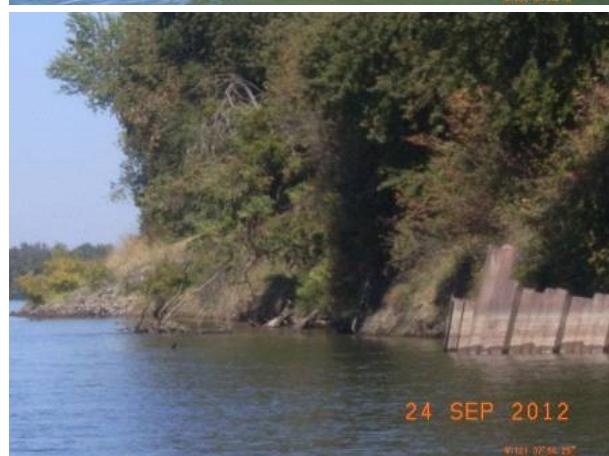
USACE 2012 Photo #2

Levee Mile Report Line	22
Start Levee Mile	11.21
End Levee Mile	11.44
Location	Water Side
Category	Supplemental
Item	USACE Erosion Survey

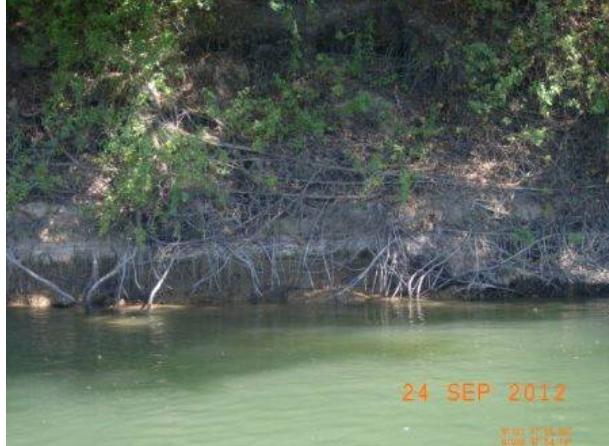
USACE 2012 Photo #3

Levee Mile Report Line	22
Start Levee Mile	11.21
End Levee Mile	11.44
Location	Water Side
Category	Supplemental
Item	USACE Erosion Survey

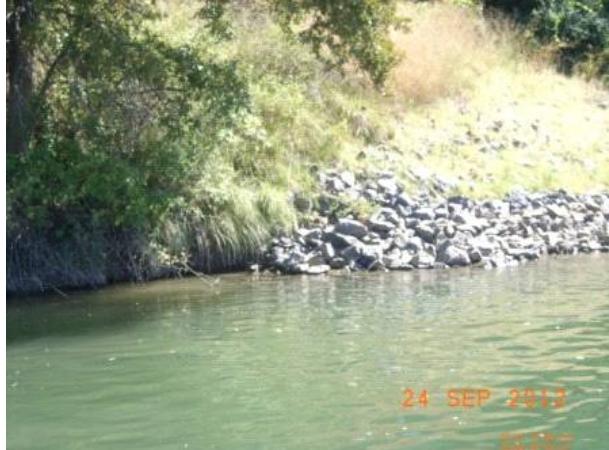
USACE 2012 Photo #4

Levee Mile Report Line	22
Start Levee Mile	11.21
End Levee Mile	11.44
Location	Water Side
Category	Supplemental
Item	USACE Erosion Survey

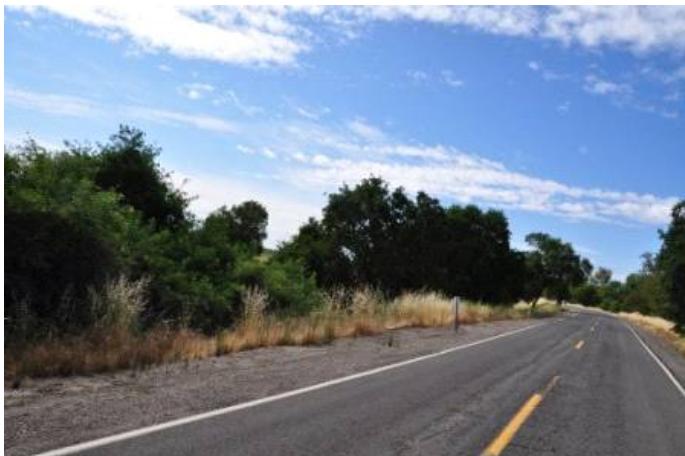
Levee Mile Report Line	23
Start Levee Mile	11.32
End Levee Mile	11.32
Location	Land Side
Category	Earthen Levee
Item	Vegetation

RD 1001 Unit 4 - L/S slope - Elderberries

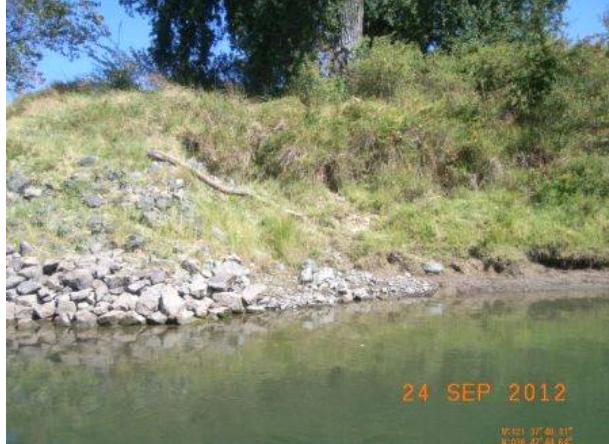
USACE 2012 Photo #1

Levee Mile Report Line	24
Start Levee Mile	11.68
End Levee Mile	11.85
Location	Water Side
Category	Supplemental
Item	USACE Erosion Survey

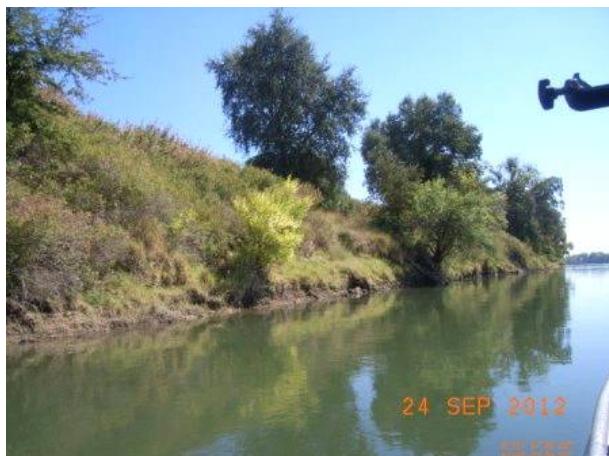
USACE 2012 Photo #2

Levee Mile Report Line	24
Start Levee Mile	11.68
End Levee Mile	11.85
Location	Water Side
Category	Supplemental
Item	USACE Erosion Survey

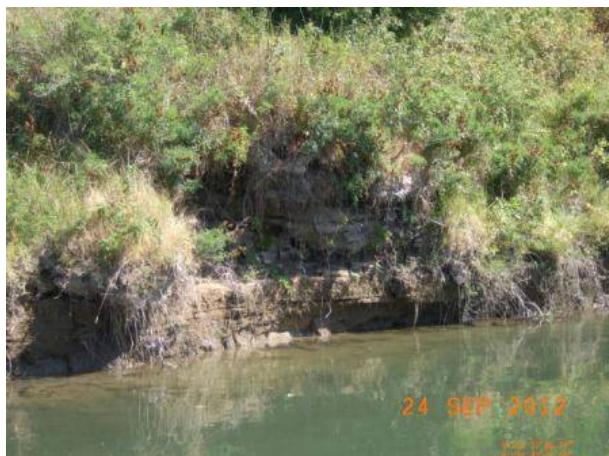
USACE 2012 Photo #3

Levee Mile Report Line	24
Start Levee Mile	11.68
End Levee Mile	11.85
Location	Water Side
Category	Supplemental
Item	USACE Erosion Survey

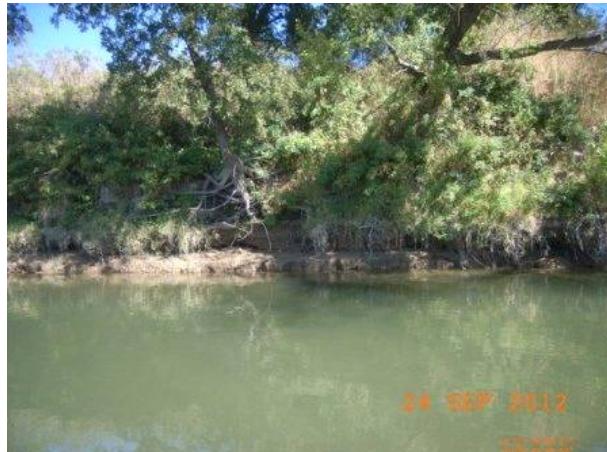
USACE 2012 Photo #5

Levee Mile Report Line	24
Start Levee Mile	11.68
End Levee Mile	11.85
Location	Water Side
Category	Supplemental
Item	USACE Erosion Survey

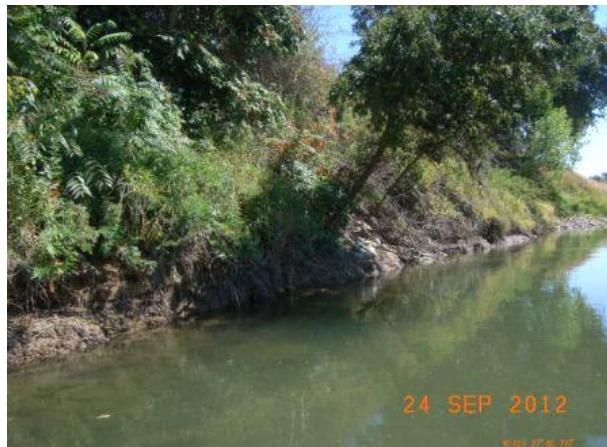
USACE 2012 Photo #6

Levee Mile Report Line	24
Start Levee Mile	11.68
End Levee Mile	11.85
Location	Water Side
Category	Supplemental
Item	USACE Erosion Survey

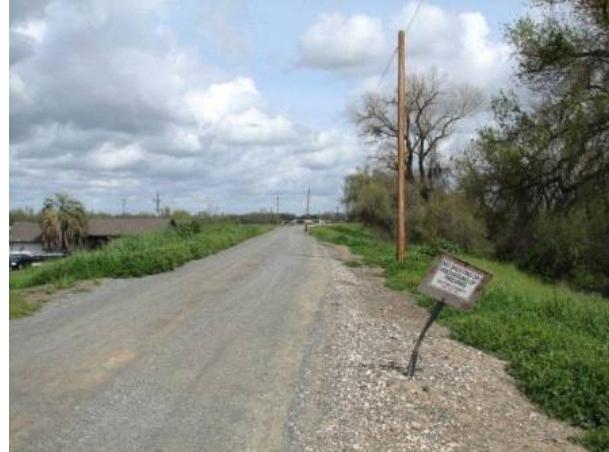
Levee Mile Report Line	1
Start Levee Mile	0.00
End Levee Mile	0.75
Location	Water Side
Category	Earthen Levee
Item	Encroachments
Poles on the water side shoulder levee mile 0.00 - 0.75	cathom_f_20120912_179.jpg

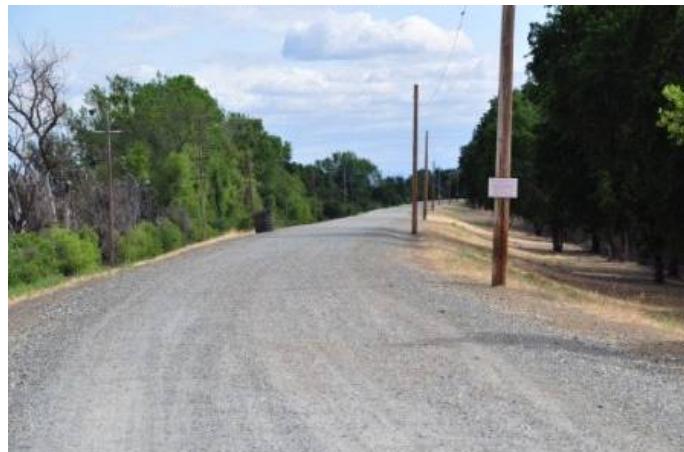
Levee Mile Report Line	1
Start Levee Mile	0.00
End Levee Mile	0.75
Location	Water Side
Category	Earthen Levee
Item	Encroachments
RD 1001 Unit 5 - W/S Levee Shoulder - Poles	cathom_f_20120912_180.JPG

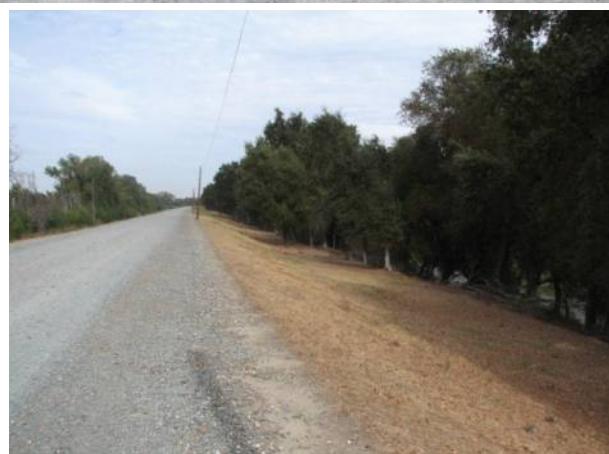
Levee Mile Report Line	2
Start Levee Mile	0.12
End Levee Mile	5.38
Location	Water Side
Category	Earthen Levee
Item	Vegetation
This photo is the waterside slope at levee mile 0.17	cathom_f_20121106_239.JPG

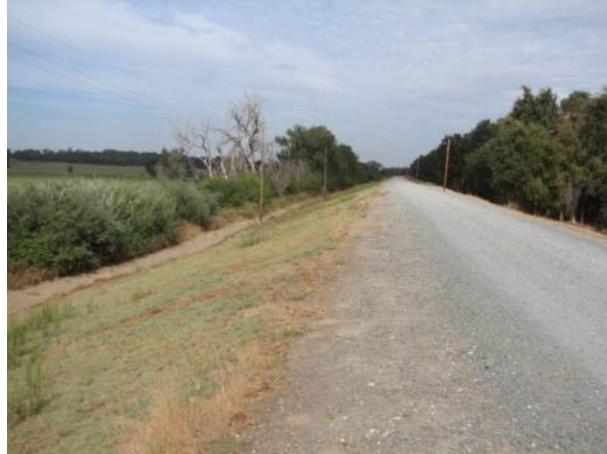
Levee Mile Report Line	3
Start Levee Mile	0.12
End Levee Mile	5.38
Location	Land Side
Category	Earthen Levee
Item	Vegetation
This photo is the landside slope at levee mile 0.17.	
cathom_f_20121106_240.JPG

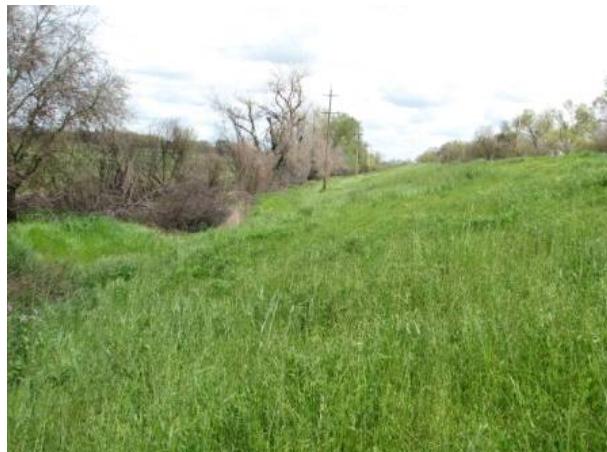
Levee Mile Report Line	4
Start Levee Mile	0.19
End Levee Mile	0.86
Location	Land Side
Category	Earthen Levee
Item	Encroachments
Poles at the land side toe levee mile 0.19 - 0.86.	
cathom_f_20120912_183.jpg

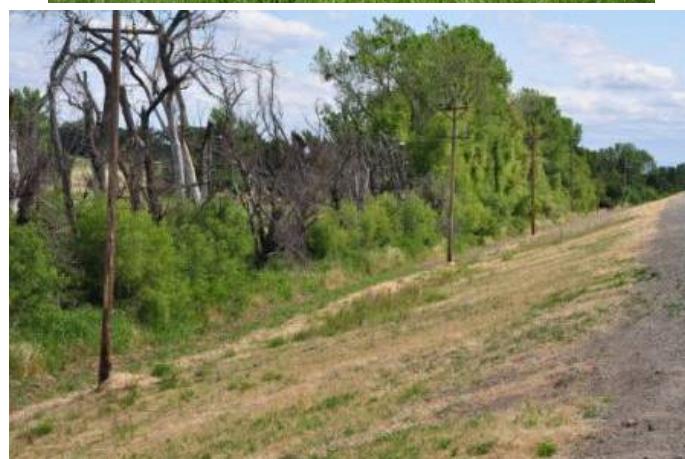
Levee Mile Report Line	4
Start Levee Mile	0.19
End Levee Mile	0.86
Location	Land Side
Category	Earthen Levee
Item	Encroachments
RD 1001 Unit 5 - L/S Levee Toe - Poles	
cathom_f_20120912_184.JPG

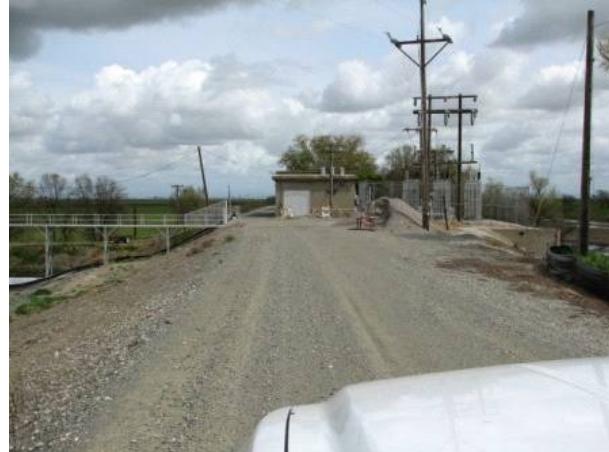
Levee Mile Report Line	5
Start Levee Mile	0.83
End Levee Mile	0.83
Location	Water Side
Category	Earthen Levee
Item	Encroachments
Pump house on the water side levee mile 0.83.	
cathom_f_20120912_181.jpg

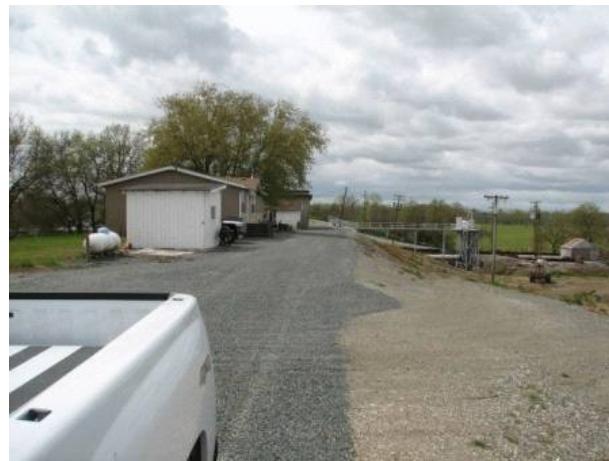
Levee Mile Report Line	5
Start Levee Mile	0.83
End Levee Mile	0.83
Location	Water Side
Category	Earthen Levee
Item	Encroachments
Pump house and Caretakers home levee mile 0.83	
cathom_f_20120912_182.jpg

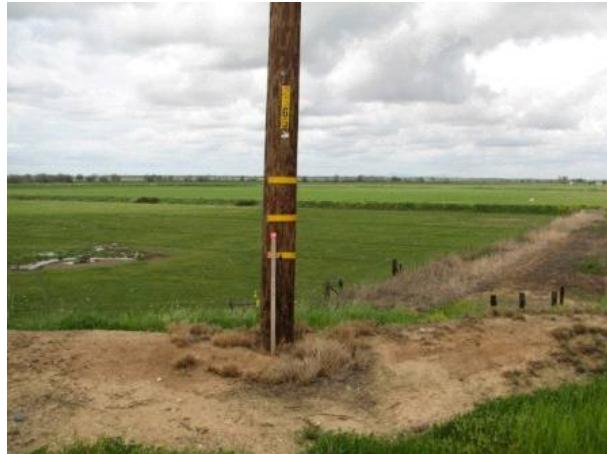
Levee Mile Report Line	6
Start Levee Mile	1.15
End Levee Mile	1.15
Location	Land Side
Category	Earthen Levee
Item	Encroachments
Pole on land side shoulder.	
cathom_f_20120912_186.jpg

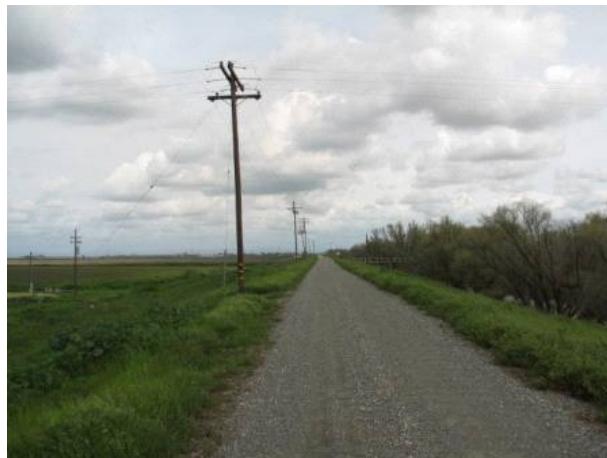
Levee Mile Report Line	8
Start Levee Mile	3.59
End Levee Mile	3.85
Location	Land Side
Category	Earthen Levee
Item	Encroachments
Poles on the land side shoulder levee mile 3.59 - 3.85.	
cathom_f_20120912_187.jpg

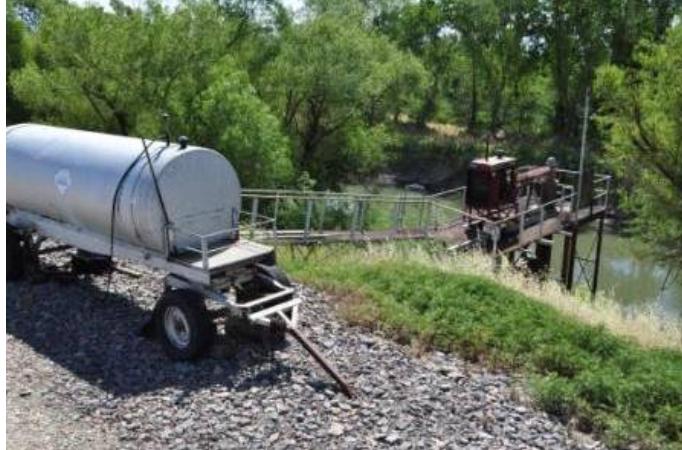
Levee Mile Report Line	10
Start Levee Mile	3.73
End Levee Mile	3.73
Location	Water Side
Category	Earthen Levee
Item	Encroachments
RD 1001 Unit 5 - W/S slope -Equipment & Portable Tank	
cathom_f_20120912_189.JPG

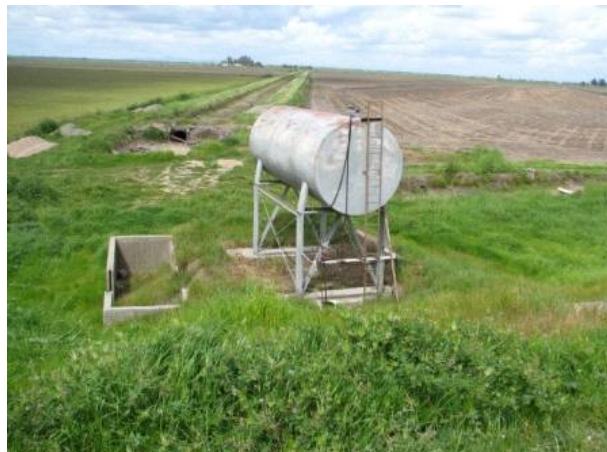
Levee Mile Report Line	12
Start Levee Mile	3.85
End Levee Mile	3.85
Location	Land Side
Category	Earthen Levee
Item	Encroachments
Storage tank on land side slope levee mile 3.85.	
cathom_f_20120912_190.jpg

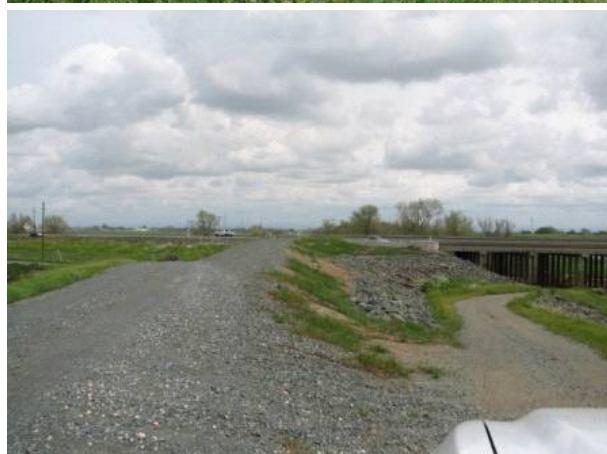
Levee Mile Report Line	13
Start Levee Mile	4.44
End Levee Mile	4.44
Location	Crown
Category	Earthen Levee
Item	Encroachments
Levee stops at hwy 70 and starts again on the other side of hwy 70.	
cathom_f_20120912_191.jpg

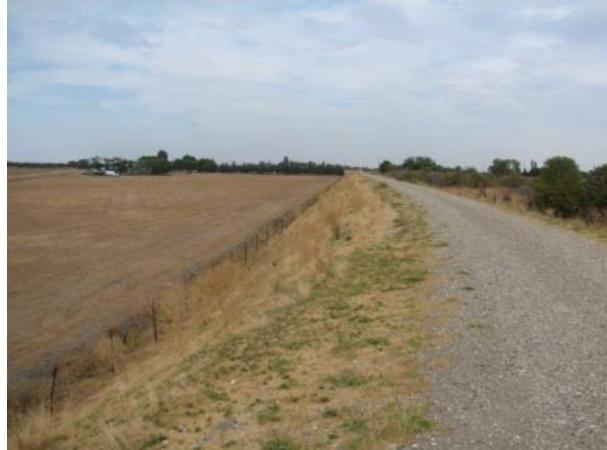
This photo is the landside levee at levee mile 0.19.

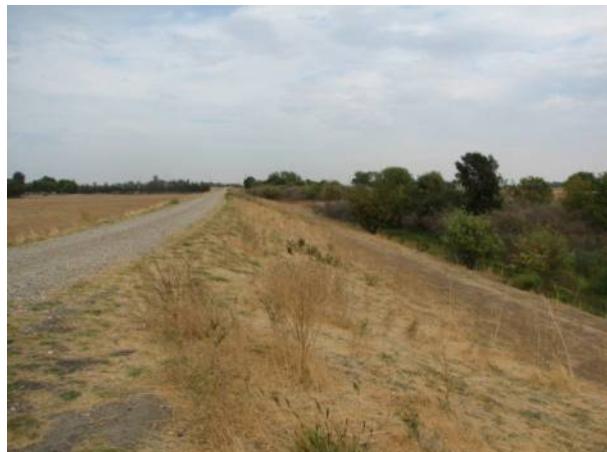
Levee Mile Report Line	2
Start Levee Mile	0.06
End Levee Mile	4.73
Location	Water Side
Category	Earthen Levee
Item	Vegetation

This photo is the waterside levee at levee mile 0.19.

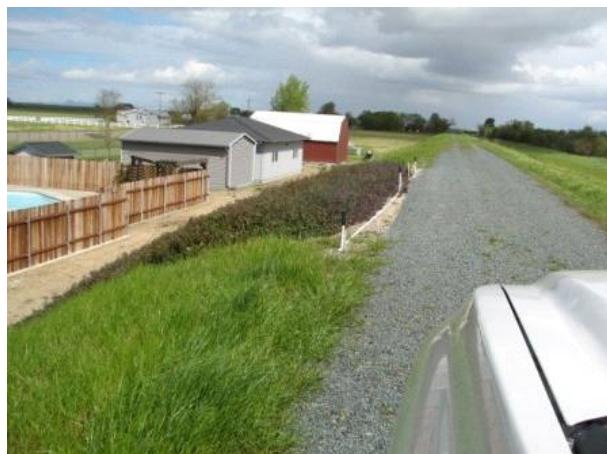
Levee Mile Report Line	4
Start Levee Mile	1.06
End Levee Mile	1.06
Location	Land Side
Category	Earthen Levee
Item	Vegetation

Landscaping on the landside slope LM 1.06.

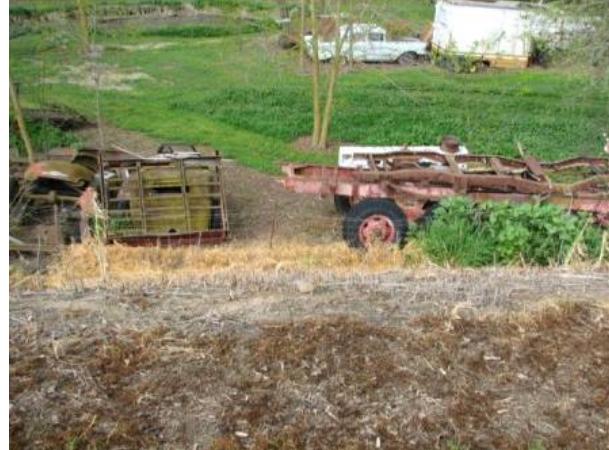
Levee Mile Report Line	6
Start Levee Mile	1.37
End Levee Mile	1.37
Location	Land Side
Category	Earthen Levee
Item	Encroachments
Equipment at the landside toe LM 1.37.	
cathom_f_20120912_195.jpg

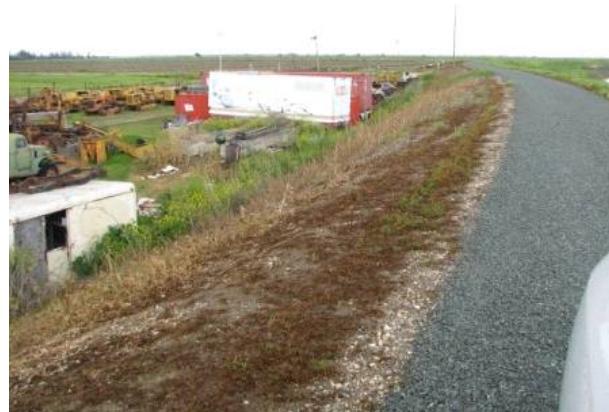
Levee Mile Report Line	7
Start Levee Mile	1.45
End Levee Mile	1.45
Location	Land Side
Category	Earthen Levee
Item	Encroachments
Equipment at the landside toe LM 1.45.	
cathom_f_20120912_193.jpg

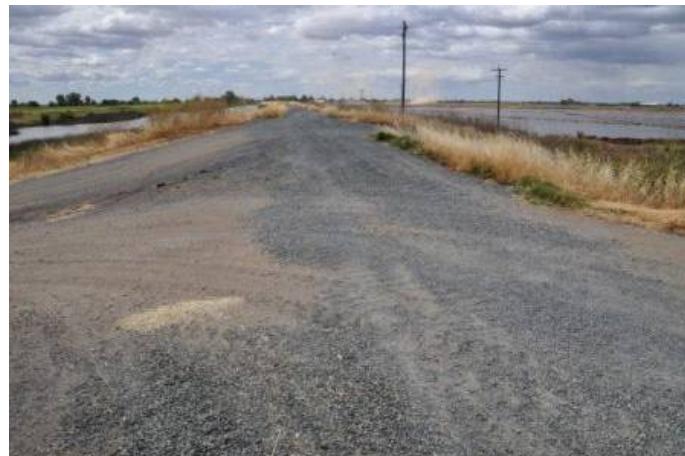
Levee Mile Report Line	9
Start Levee Mile	2.06
End Levee Mile	2.06
Location	Crown
Category	Earthen Levee
Item	Slope Stability
RD 1001 Unit 6 - Levee Crown - Subsidence due to vehicle traffic.	
cathom_f_20120912_197.JPG

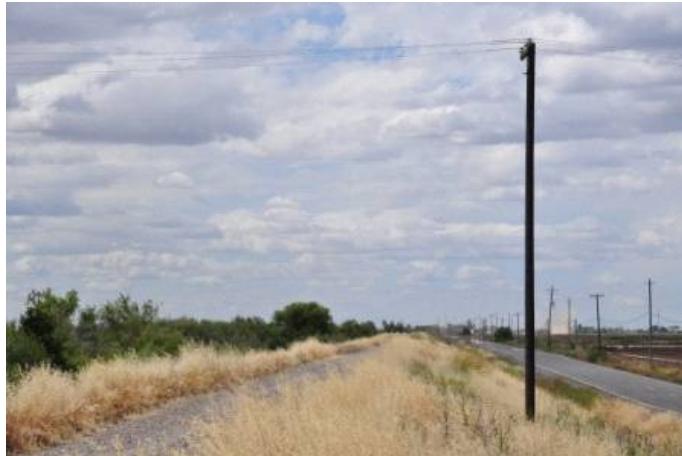
Levee Mile Report Line	10
Start Levee Mile	3.79
End Levee Mile	3.79
Location	Land Side
Category	Earthen Levee
Item	Encroachments
RD 1001 Unit 6 - L/S Slope - Pole	
cathom_f_20120912_200.JPG
